APPENDIX D

Technical Appendices

APPENDIX D4
*Borrego Springs Subbasin Groundwater
Dependent Ecosystems*

DRAFT FINAL TECHNICAL MEMORANDUM

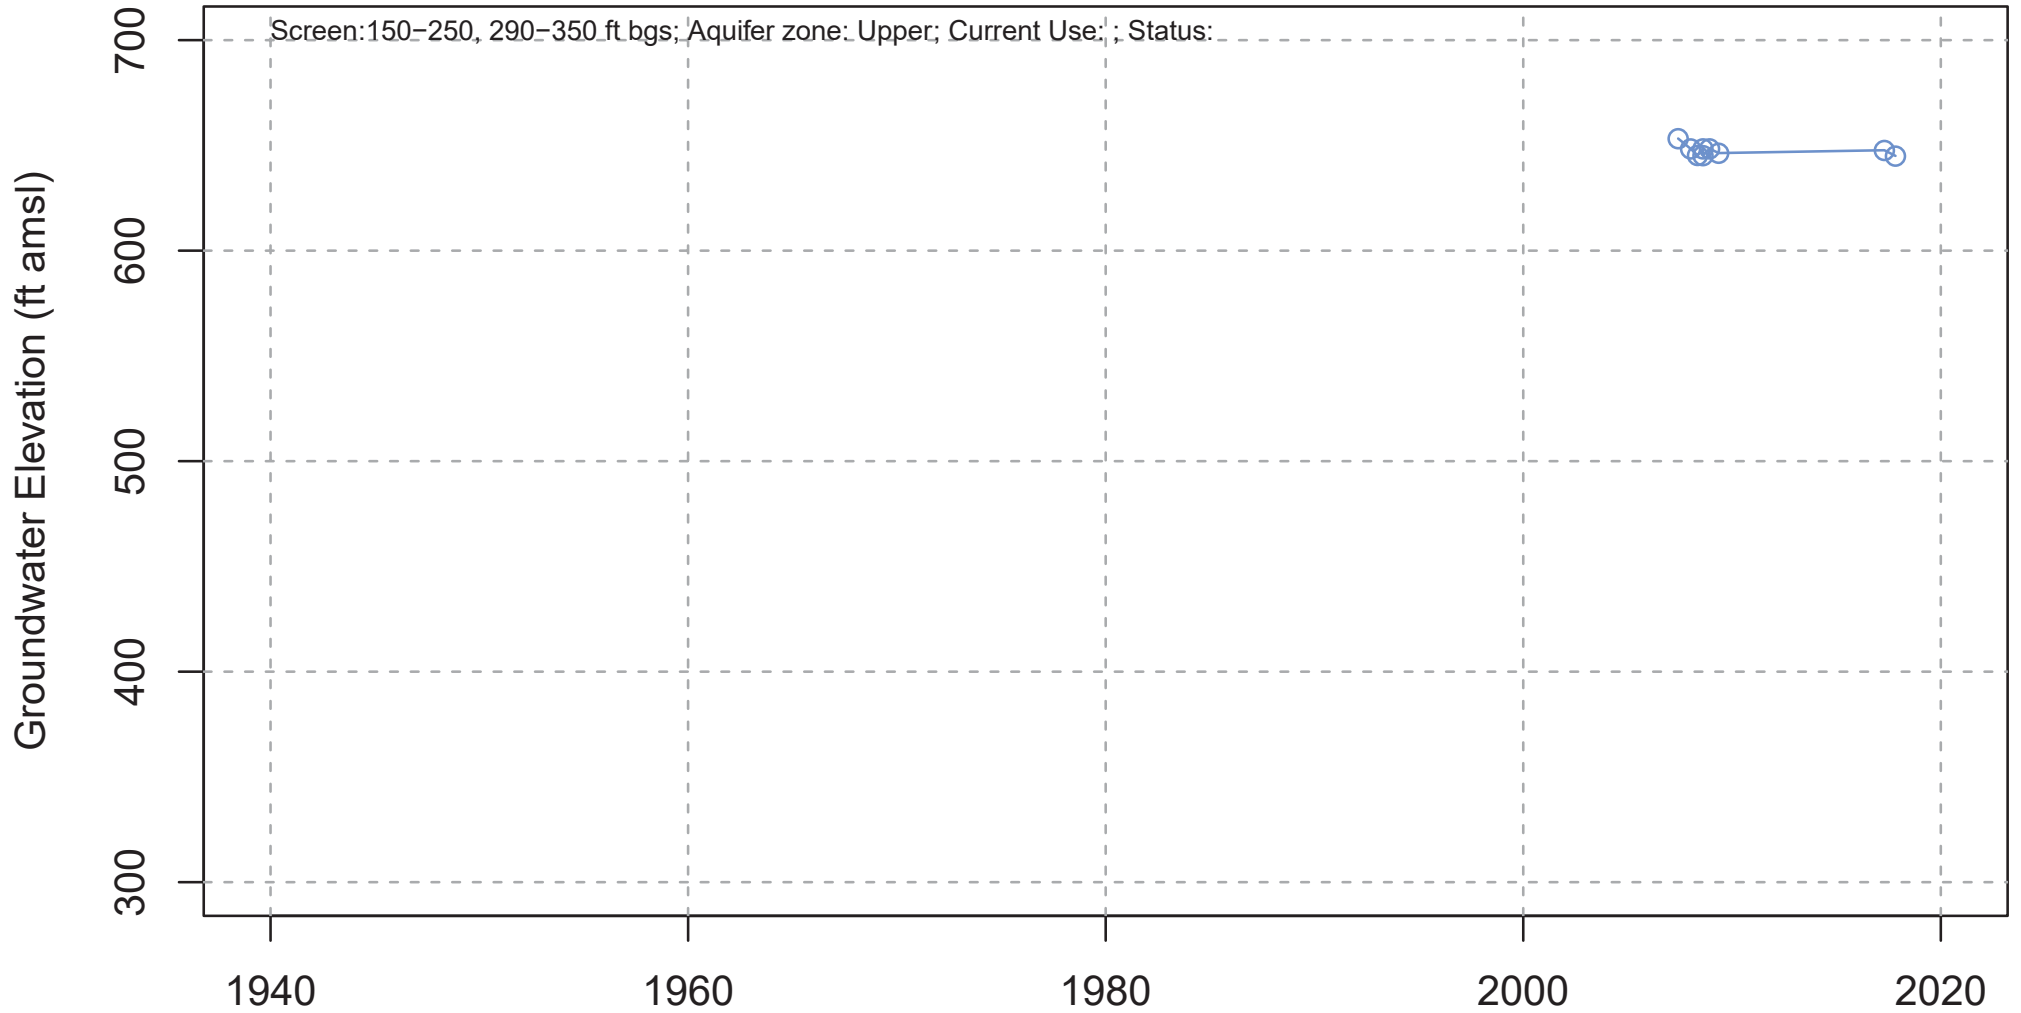
009S006E31E003S

Local ID: Horse Camp ; Number of Measuring Agency(ies): 4

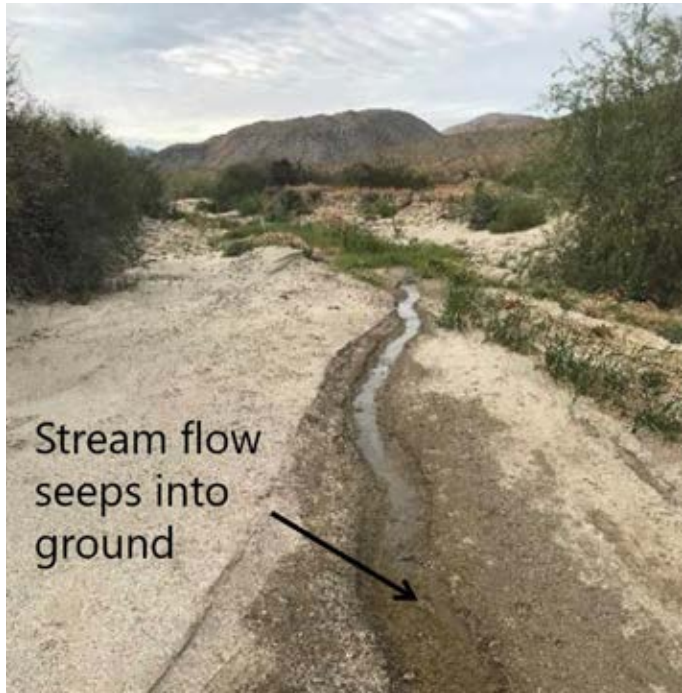
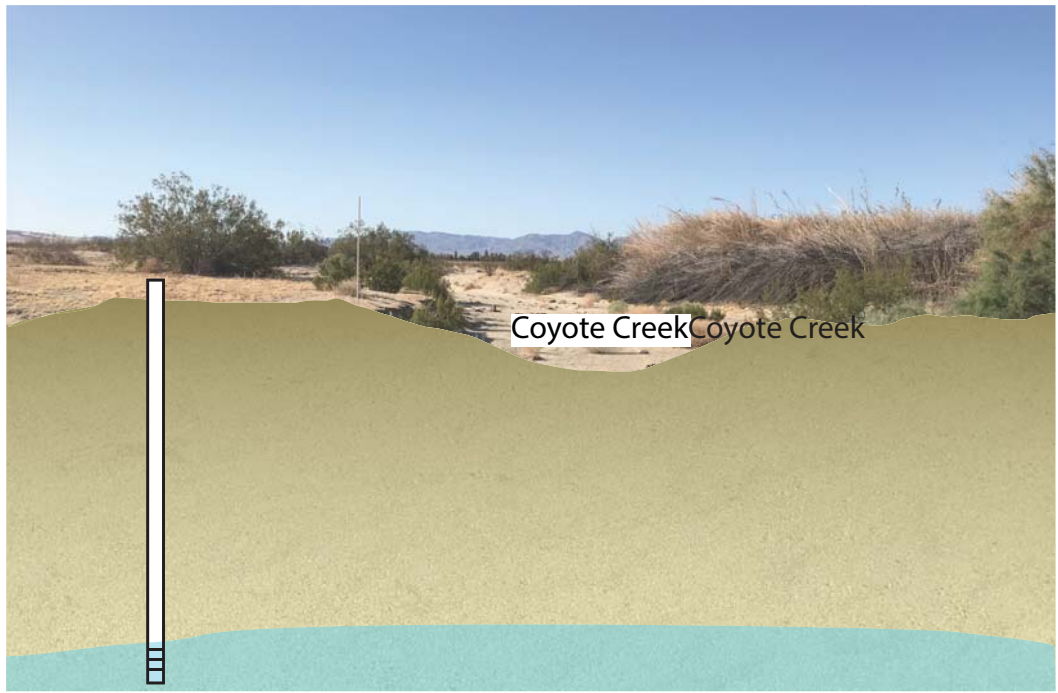
FIGURE 21

Figure 21	Contributing Watersheds Hydrogeologic Conceptual Model
Figure 22	Borrego Sink (Mesquite Bosque) Hydrogeologic Conceptual Model

- 1 Source of water for perennial streams and NCCAGs is outside the basin boundary
- 2 Perennial streams transition to disconnected streams
- 3 Ephemeral streams lose water through a thick unsaturated zone
- 4 Cone of depression for pumping wells do not intersect GDEs

A HCM was developed for the potential GDEs identified in the Subbasin and at the Subbasin margins. Figure 21 depicts a HCM applicable to GDE Unit 1 – Coyote Creek, GDE Unit 2 – Borrego Palm Creek and other similar canyons that drain mountainous terrain adjacent to the Subbasin. This HCM illustrates that the source of water for potential GDE Units 1 and 2, and other similar canyons is stream flow that originates from outside of the Subbasin. Ephemeral and perennial streams transition to disconnected streams as they flow across the numerous alluvial fans that descend on the Subbasin. Stream flow percolates into a thick unsaturated zone. The regional groundwater table is often hundreds of feet below the streams. At Coyote Creek, the nearest well, State Well ID No. 009S006E31E003SI, has a depth to groundwater of 288 feet below land surface. At Borrego Palm Canyon Creek, the nearest well, State Well ID No. 010S005E25R002S, has a depth to groundwater of 348 feet below land surface. Other wells located adjacent to the Subbasin margins all have depths to groundwater several hundred feet below land surface.
