**Borrego Water District Board of Directors  
Special Meeting  
April 15, 2025 @ 9:00 A.M.  
806 Palm Canyon Drive  
Borrego Springs, CA 92004**

# **GDE Identification and Monitoring Program Report and Recommendations**

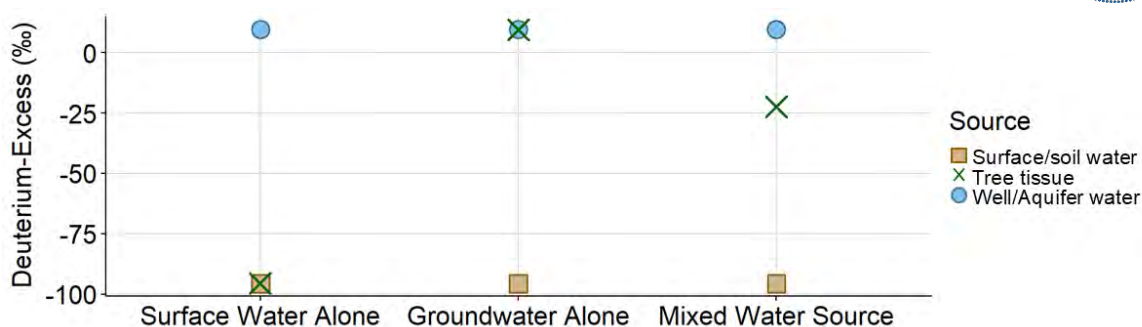
**Figure 2.8.** Expected behavior of deuterium-excess, a useful indicator of evaporative effects calculated using both  $\delta^{18}\text{O}$  and  $\delta^2\text{H}$ , found under different water-use contexts by trees (see Methods for greater detail). For *Surface Water Alone* there is an overlap of the deuterium-excess of the soil water and tree tissue water. Any variance in the tree tissue water data should be explained by the variance in the soil water signal. In the *Groundwater Alone* scenario (not expected but included as a hypothetical comparison), there is no overlap between the soil water deuterium-excess data and the tree deuterium-excess data; all variance in tissue deuterium-excess is explained by the groundwater isotope signal. In the *Mixed Water Source* scenario, the tree tissue deuterium-excess is intermediate between the soil water and groundwater deuterium-excess. This can be conceptualized by the notion that the surface water signal is diluted by the groundwater signal in the tree tissue.

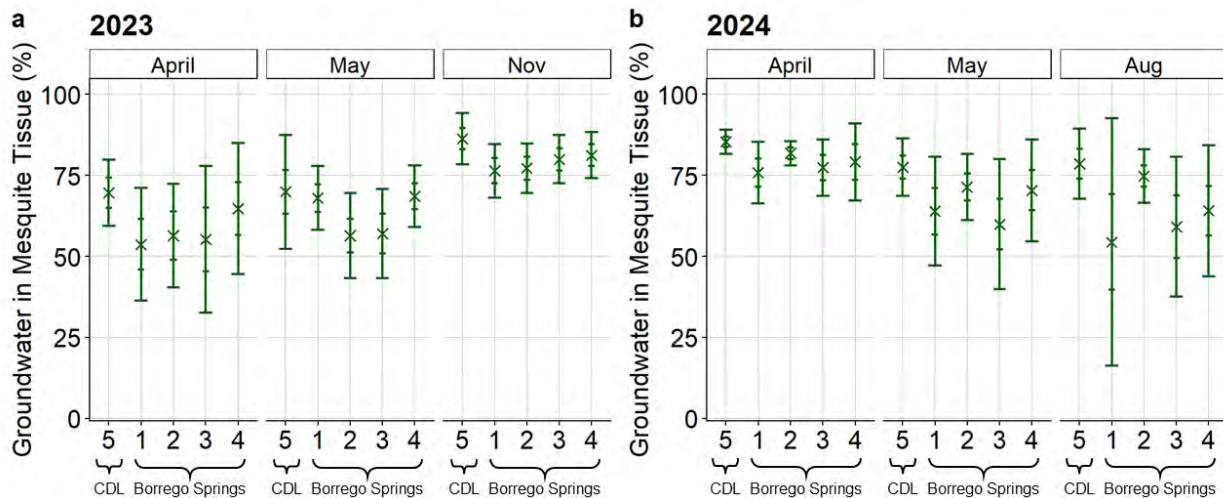
**Figure 2.15.** Groundwater fraction in plant tissues calculated from deuterium-excess of the soil water, tree tissue water, and well water for each of the five sentinel sites in Borrego Springs and the reference site at Clark Dry Lake using a two-end mixing model as in Equation 3. Well water is a value derived from the most-adjacent well sample possible (an average of MW-3 and MW-5A for Sites 1 - 4 and 10S07E07C001S for Site 5).

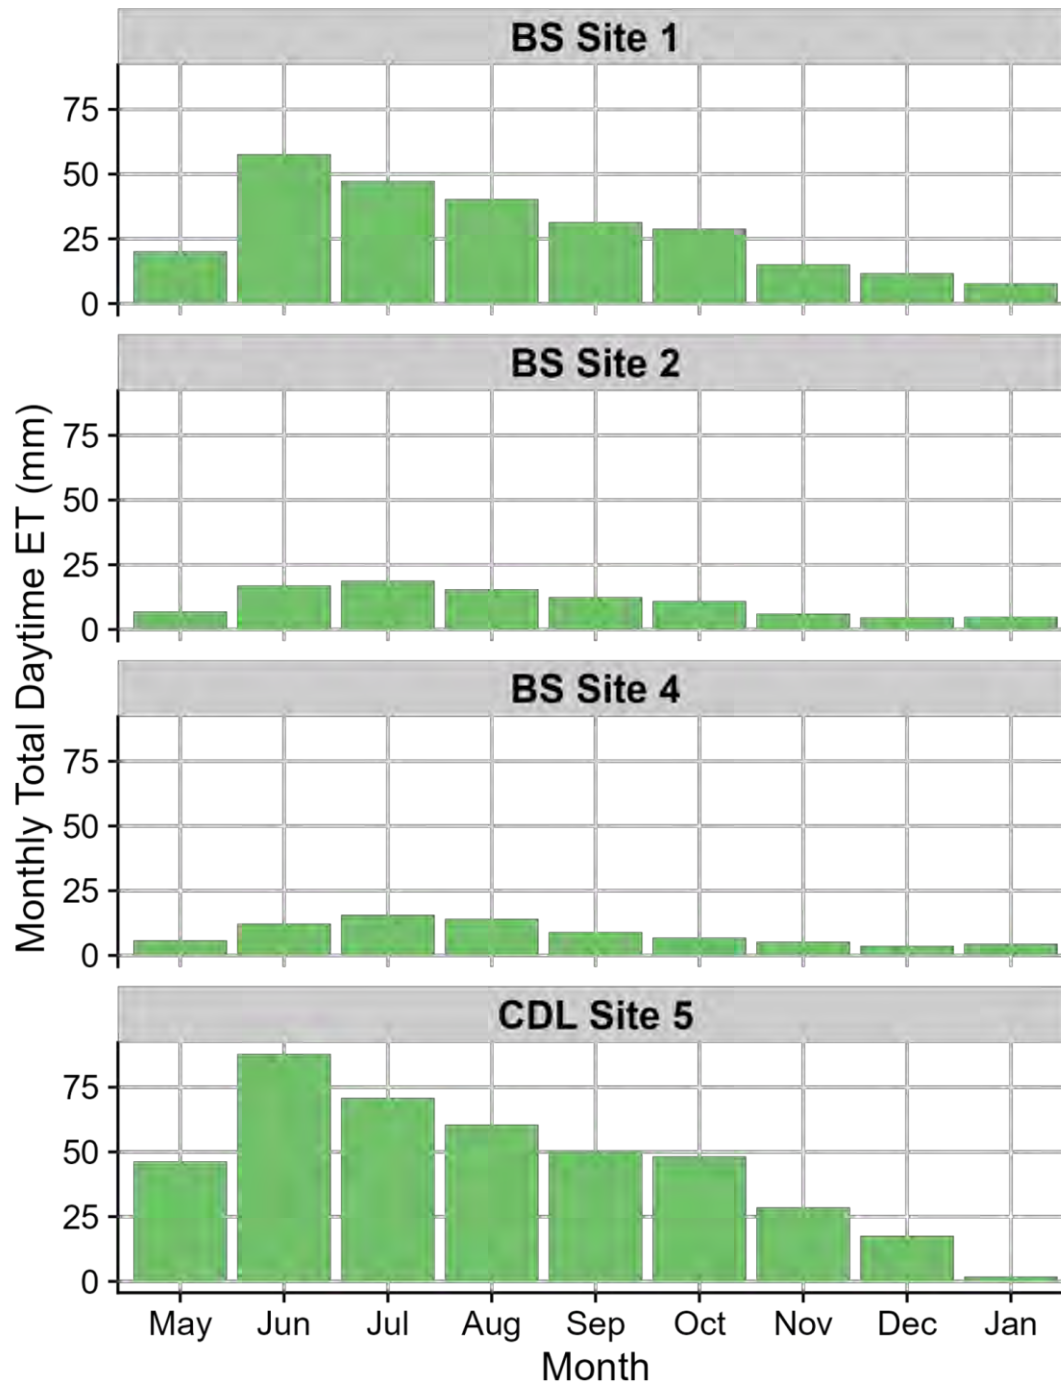
**Figure 2.22.** Monthly Total Evapotranspiration (ET) from each site. Sites 1 and 5 had the greatest total monthly ET in the month of June. Sites 2 and 4 had the highest ET in July. All sites displayed consistent, positive ET throughout the dry deployment period, indicating access to groundwater. BS: Borrego Springs; CDL: Clark Dry Lake.

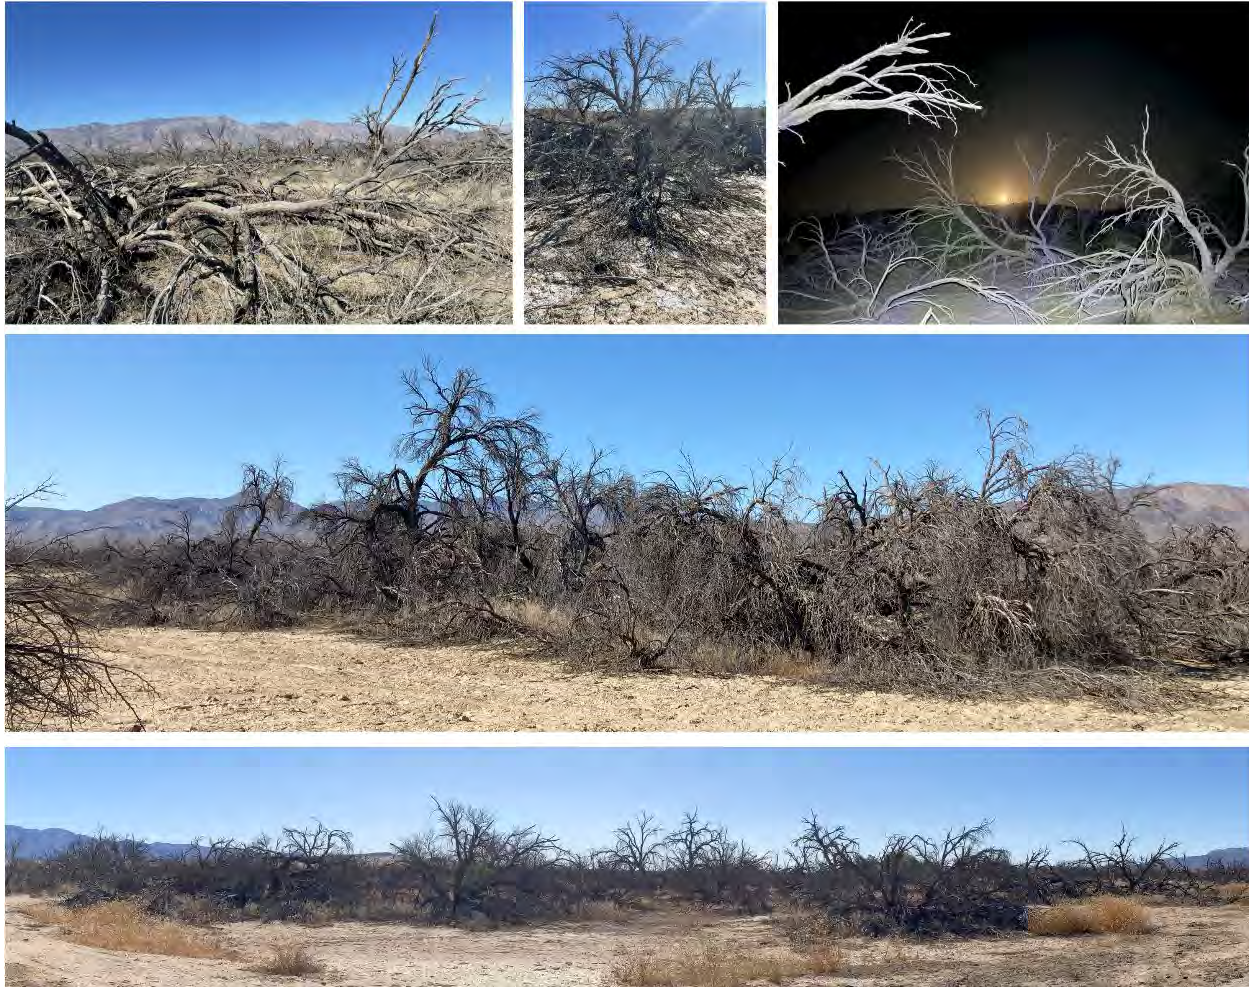
**Figure 4.9.** Examples of mesquite bosque habitat that have experienced declines in health. Photos were taken by the GDE Project team in 2023 and 2024.

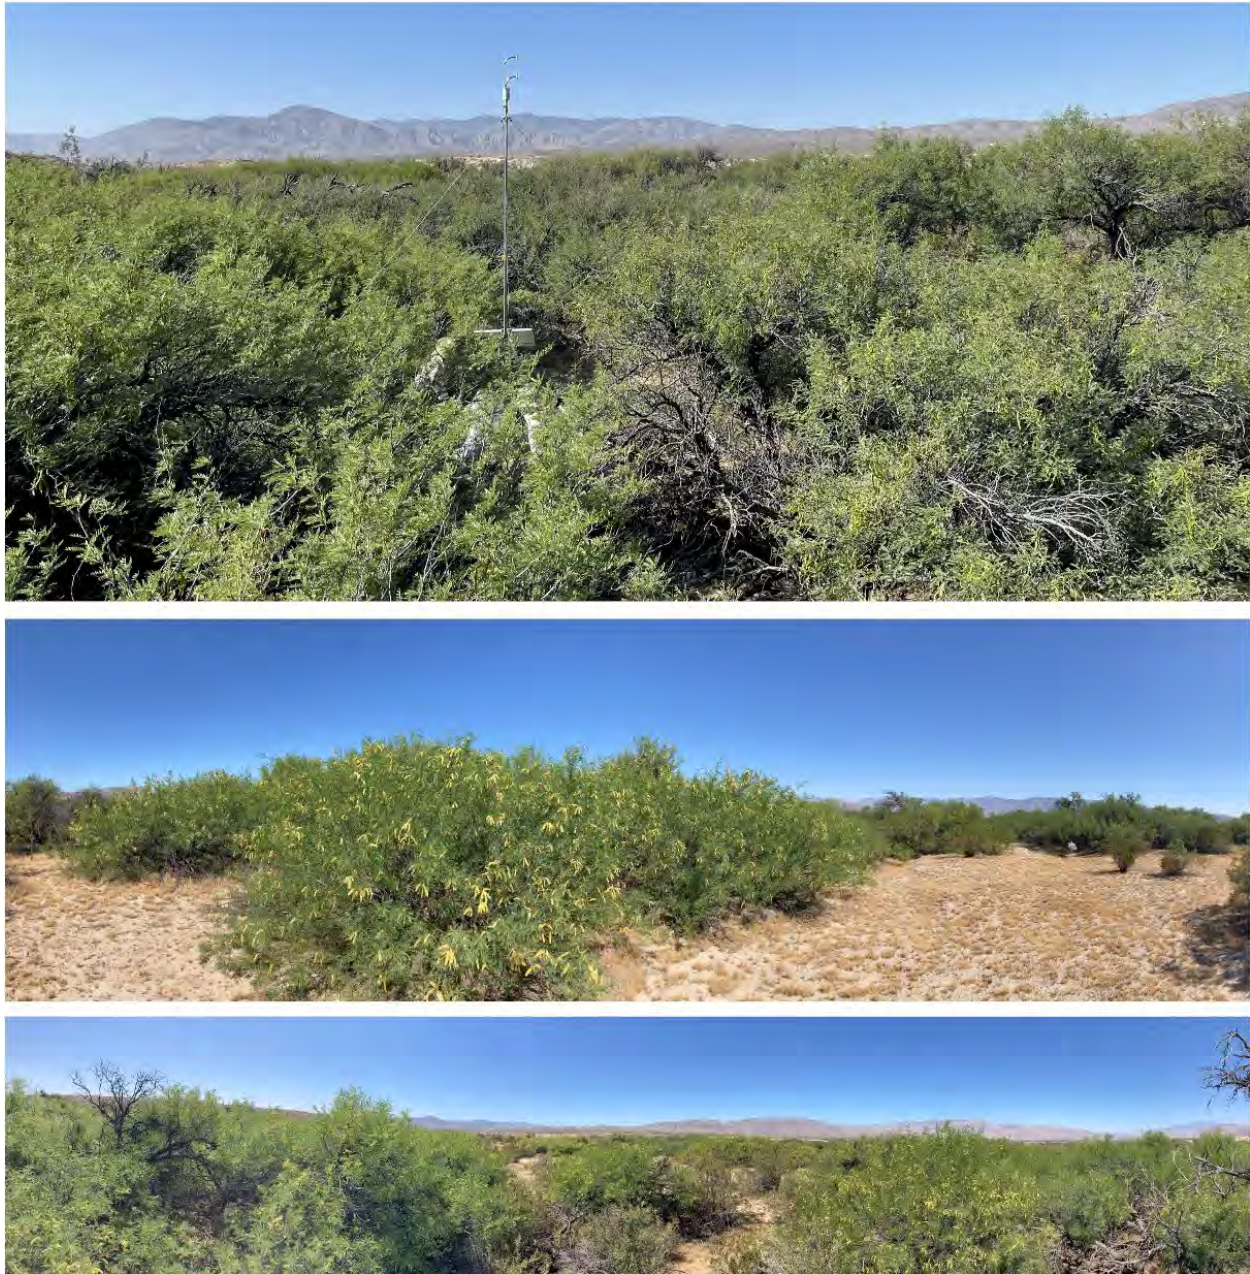
**Figure 4.10.** Examples of healthy mesquite bosque habitat that show stability or improvements in health. Photos were taken by the GDE Project team in 2023 and 2024.

groundwater is closer to the surface (shown in tan and blue in Figure 4.7; see photos in Figure 4.10). Notably, the mesquite bosque habitat near the wastewater treatment plant shows some of the strongest increases in mesquite health over time.

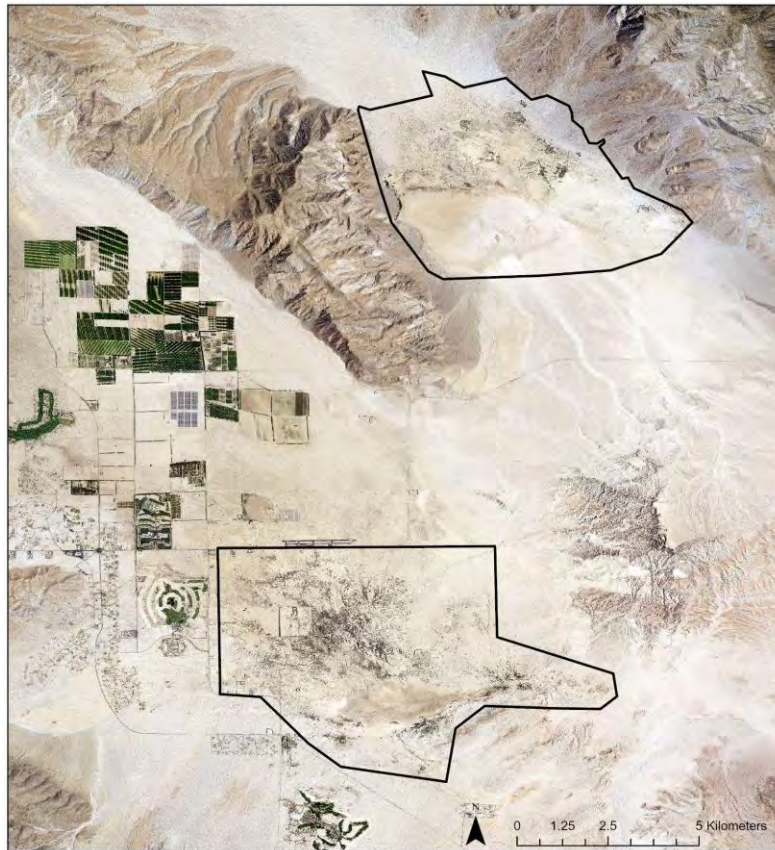
**Figure A1.** The areas across which image classification was performed.

We conducted the supervised image classification for our two primary sites separately. In the Borrego Springs Subbasin, we used the Palm Canyon Drive and Borrego Valley Road as our north and west bounds, respectively. To the south and east, we used the extent of mesquite within the Borrego Springs Subbasin as our bounds (Figure A1). At Clark Dry Lake, we included the expanse between the feet of the two mountain ranges bounding the lake to the east and west (Figure A1). Training samples took the form of polygons (Table A1). There were some spots in the Clark Dry Lake area that had been mapped by the County of San Diego (SanGIS, 2022) as mesquite bosque that were challenging to determine from aerial imagery whether the vegetation was mesquite or creosote bush, so our partners at the San Diego Natural History Museum investigated on the ground. After classification, classes other than Live Mesquite were reclassified as Barren to simplify validation, as only the Live Mesquite category was of interest. For validation, we used 100 random assessment points per category (equal stratification for Live Mesquite and Barren) for each primary site. We report user's accuracy, producer's accuracy, overall accuracy, and kappa (Congalton 1991). User's accuracy indicates the probability that a classified object actually represents that category according to the validation data. Overall accuracy is the percentage of true positives. Kappa evaluates the performance of the classification compared to random assignment where values closer to one indicate the classification is
